RIO GRANDE FLOODWAY
Truth or Consequences Unit, NM

FOUNDATION REPORT, Volume I Report, Photographs, and Appendix A

FOUNDATION REPORT DECEMBER 1992

# RIO GRANDE FLOODWAY, T. OR C. UNIT, N.M. FOUNDATION REPORT RCC DAM, EMBANKMENT DAM, RCC SPILLWAY, AND OUTLET WORKS

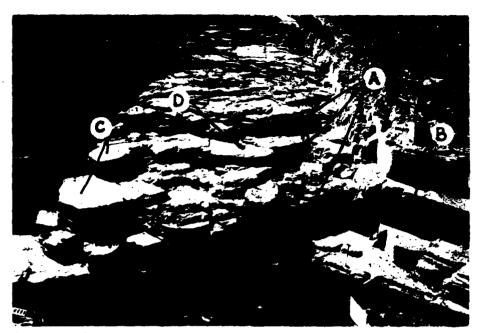
Photo No. 1 - Looking southwest along the dam alignment at the right abutment foundation trench illustrating the four primary joint sets. 14 March 1991

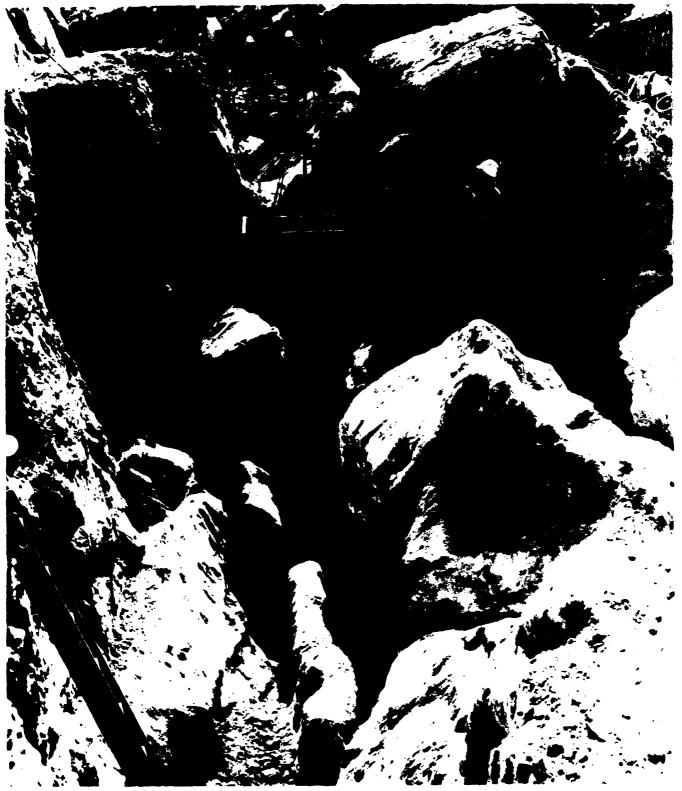
Photo No. 21 - Looking south-southeast along the left abutment of the foundation trench at solution cavities. 23 January 1991

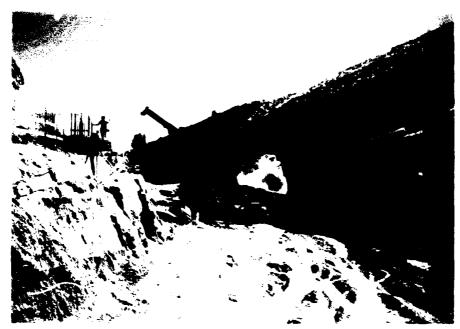
Photo No. 28 - Looking southeast at the channel bottom illustrating quicksand nature of saturated alluvium. Note buried excavator near center of photo. 12 October 1990
